**Allstate Tower, Inc.**

| JOB NO: | 25071A |
| TYPE OF TOWER: | GUYED TOWER |

## **ALLSTATE TOWER INSPECTION REPORT TABLE OF CONTENTS**

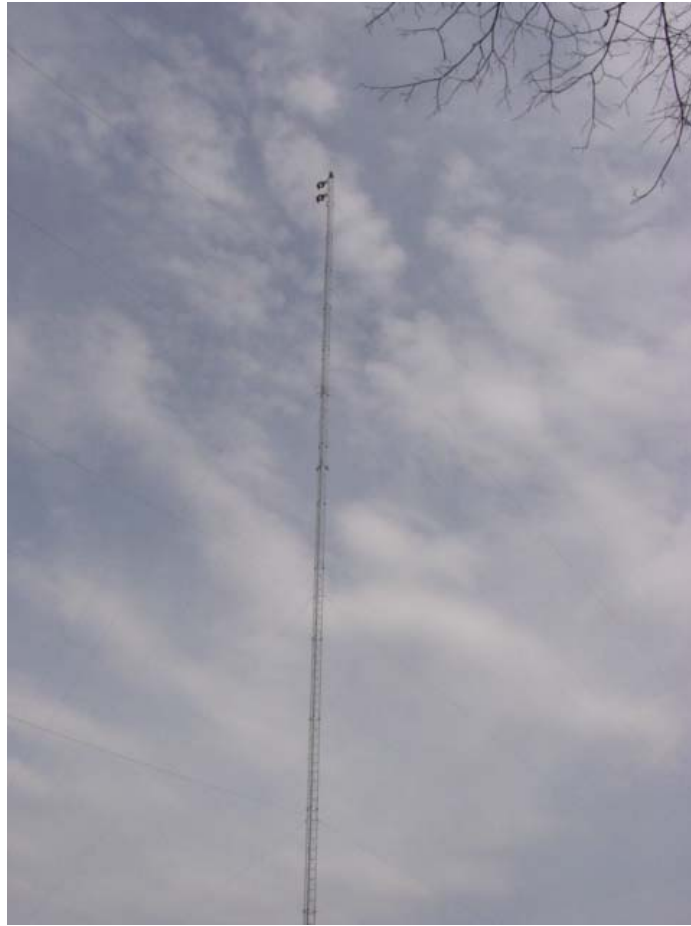
PHOTO SHOWS OVERALL VIEW OF THE TOWER.

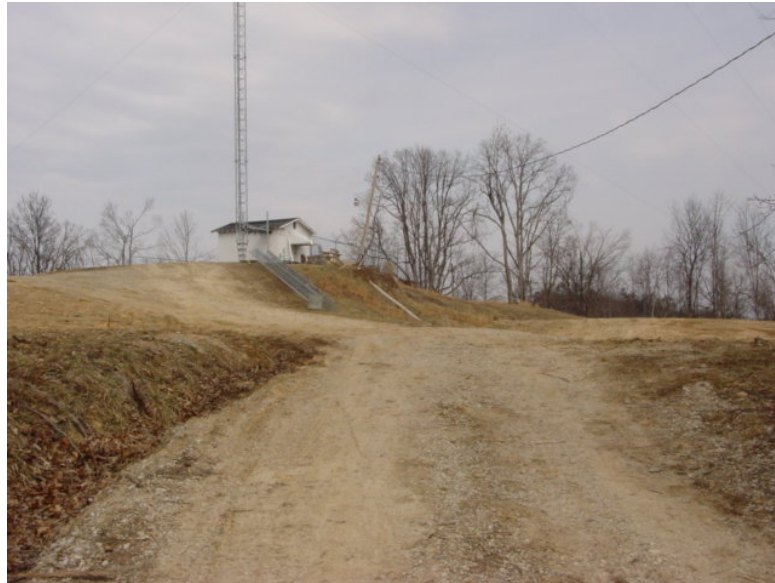
PHOTO SHOWS ACCESS ROAD.

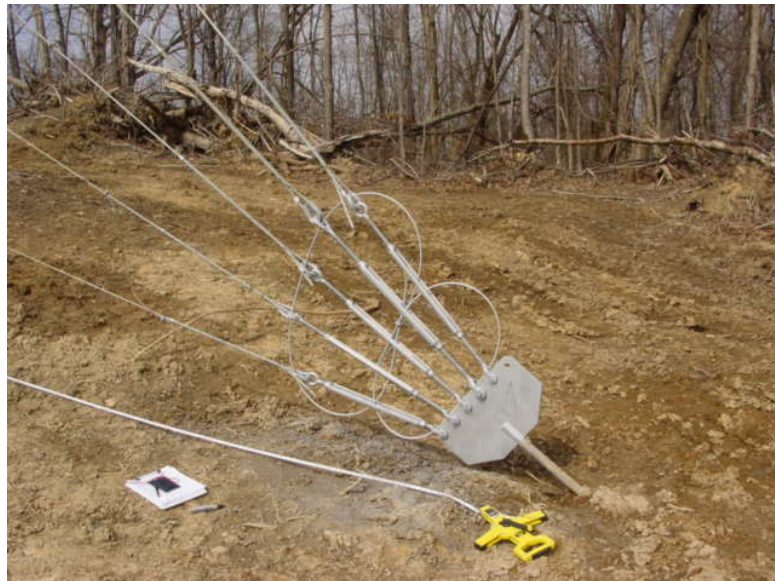
| <b>2A</b> | ANCHORS NOT FENCED IN AND/OR IS INADEQUATE. THIS ALLOWS UNAUTHORIZED ACCESS TO THE ANCHORS. WE RECOMMEND TO INSTALL ADEQUATE FENCING AROUND ANCHORS. |

ANCHORS NOT FENCED IN AND/OR IS INADEQUATE. THIS ALLOWS UNAUTHORIZED ACCESS TO THE ANCHORS. WE RECOMMEND TO INSTALL ADEQUATE FENCING AROUND ANCHORS.

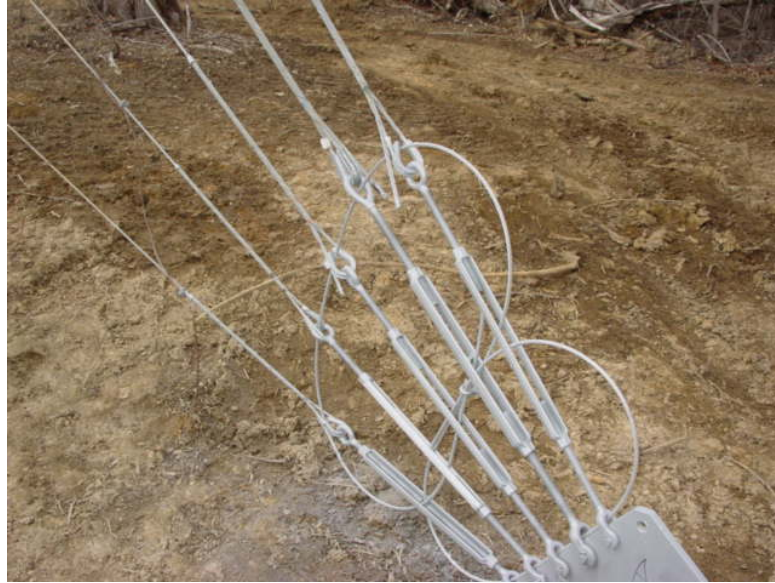
PHOTO SHOWS ANCHOR A.

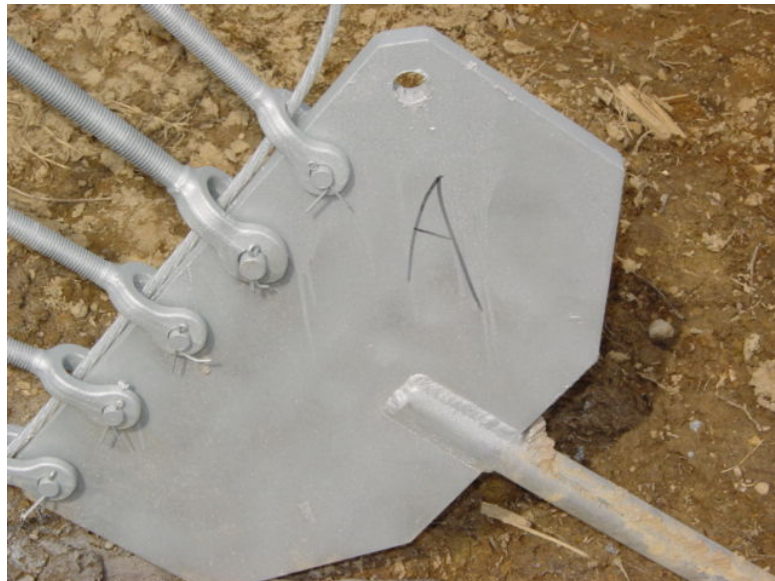
PHOTO SHOWS ANCHOR A.

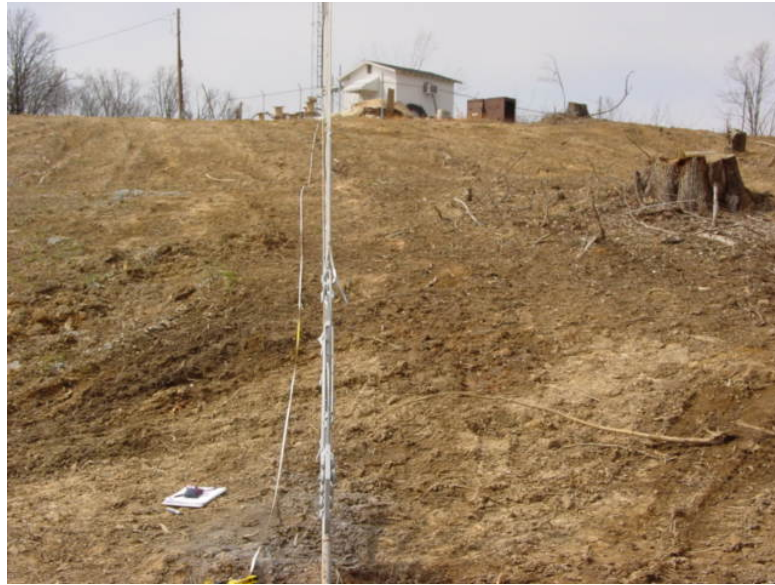
PHOTO SHOWS ANCHOR A.

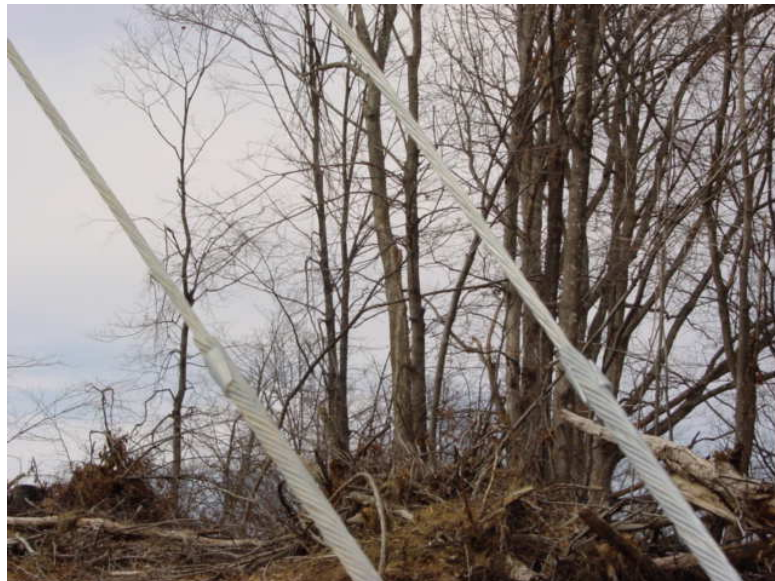
PHOTO SHOWS GUY WIRE AT ANCHOR A.

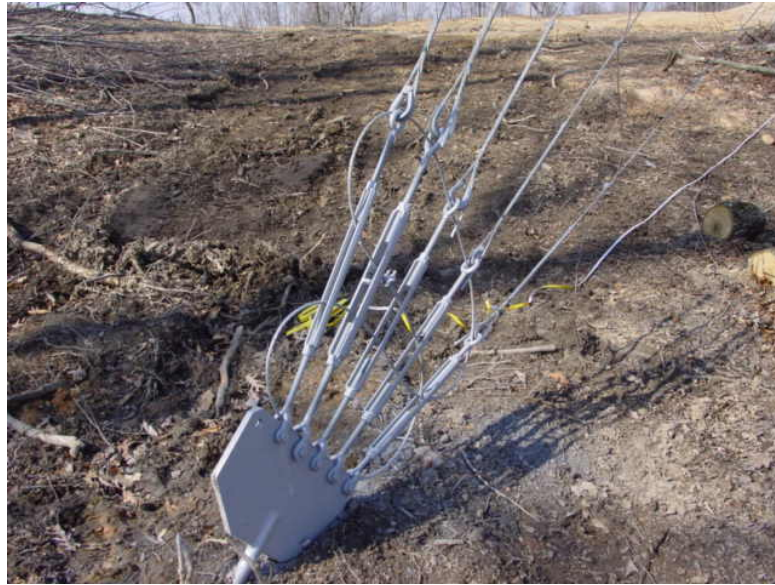
ANCHORS NOT FENCED IN AND/OR IS INADEQUATE. THIS ALLOWS UNAUTHORIZED ACCESS TO THE ANCHORS. WE RECOMMEND TO INSTALL ADEQUATE FENCING AROUND ANCHORS.

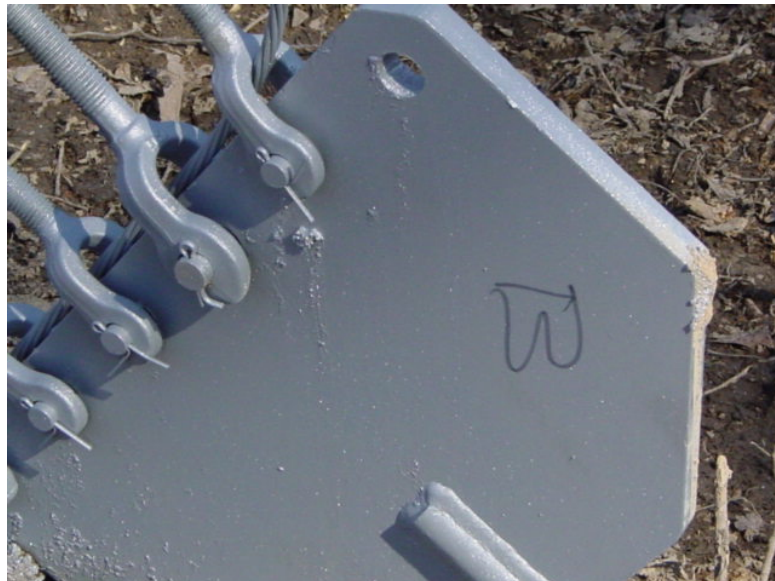
PHOTO SHOWS ANCHOR B.

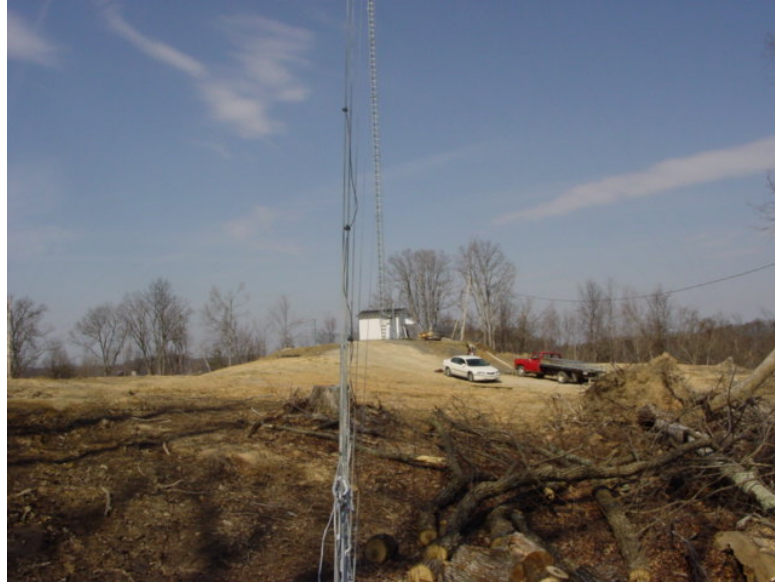
PHOTO SHOWS ANCHOR B.

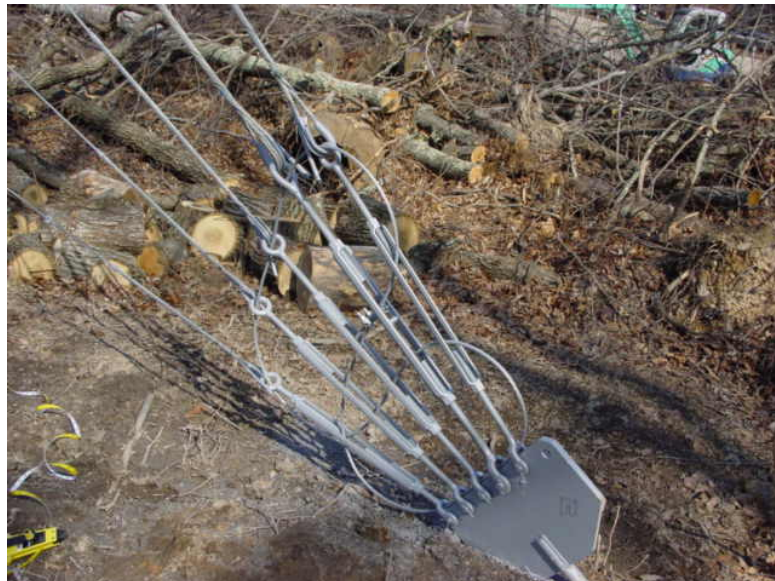
PHOTO SHOWS ANCHOR B.

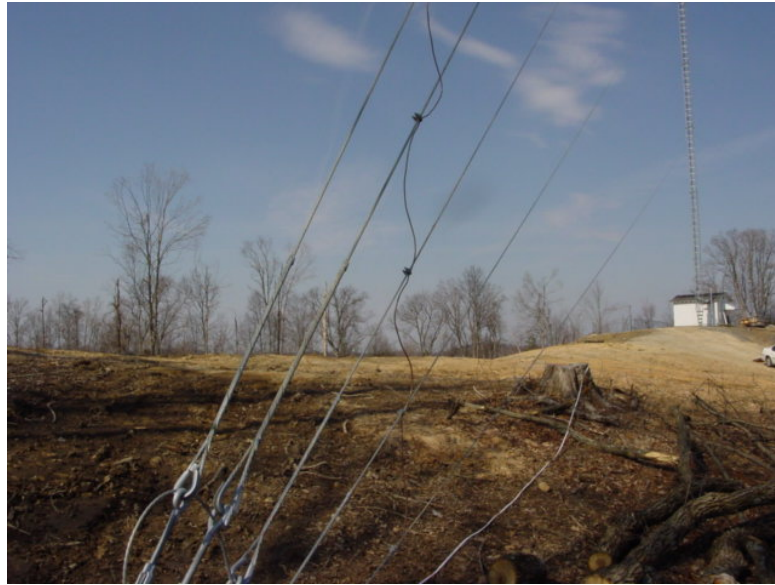
PHOTO SHOWS GUY WIRES AT ANCHOR B.

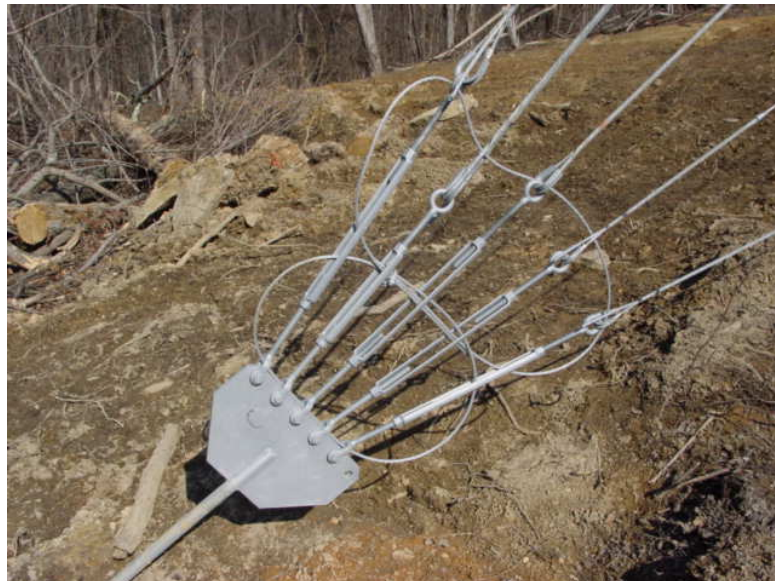
ANCHORS NOT FENCED IN AND/OR IS INADEQUATE. THIS ALLOWS UNAUTHORIZED ACCESS TO THE ANCHORS. WE RECOMMEND TO INSTALL ADEQUATE FENCING AROUND ANCHORS.

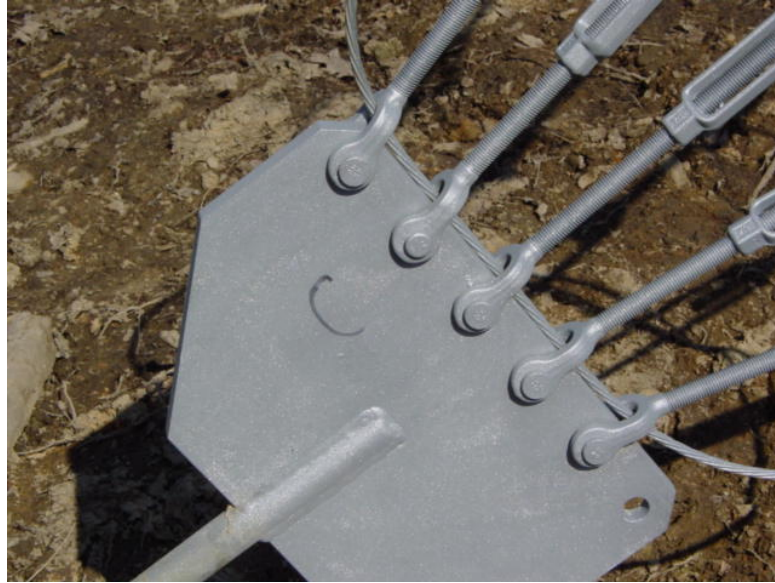
PHOTO SHOWS ANCHOR C.

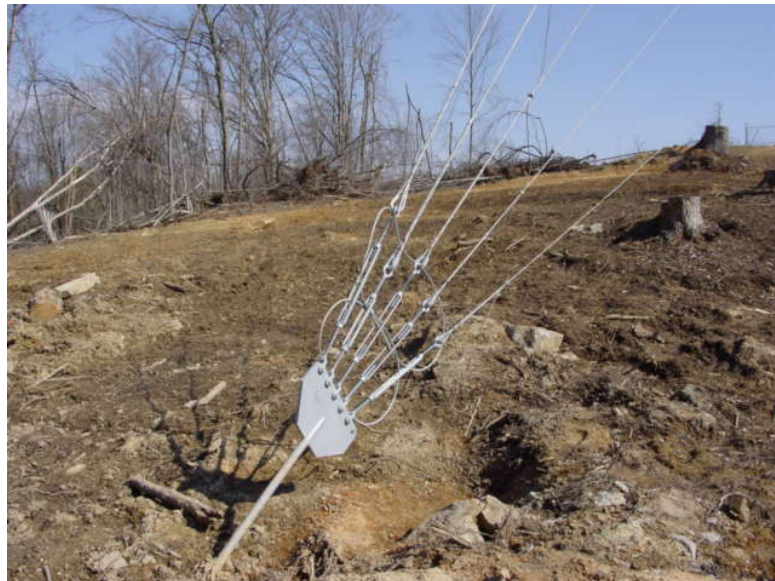
PHOTO SHOWS ANCHOR C.

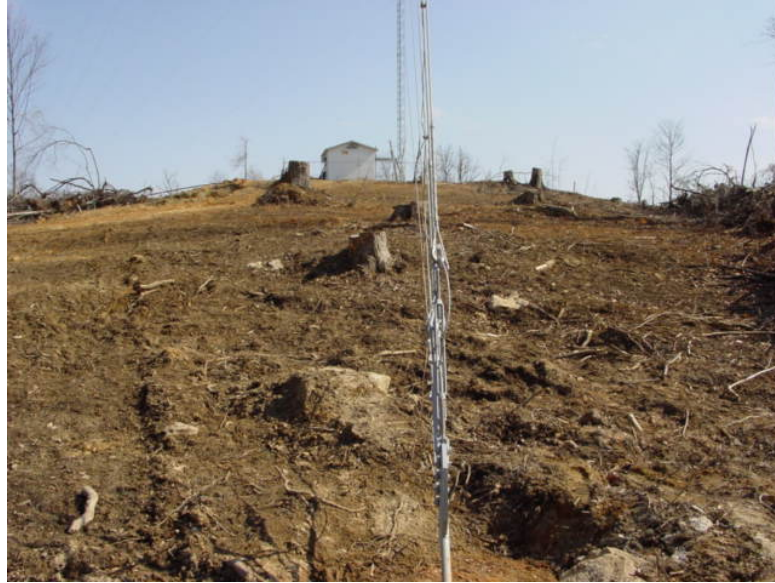
PHOTO SHOWS ANCHOR C.

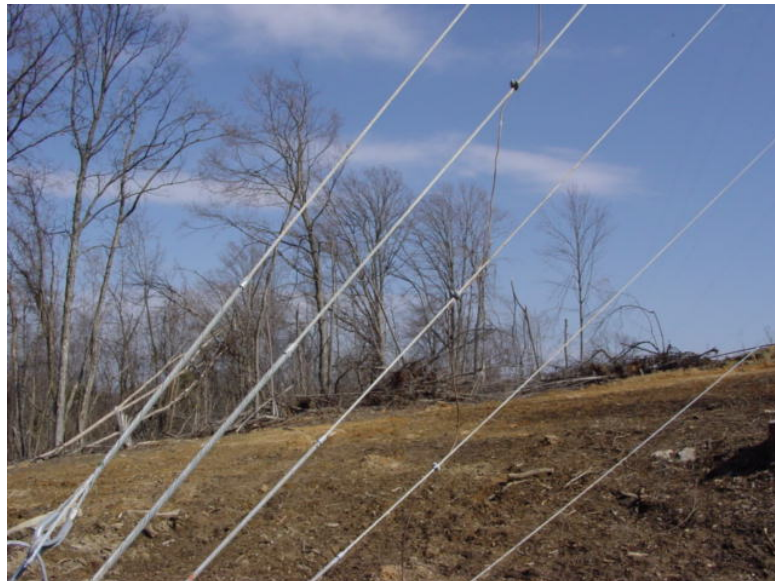
PHOTO SHOWS GUY WIRES AT ANCHOR C.

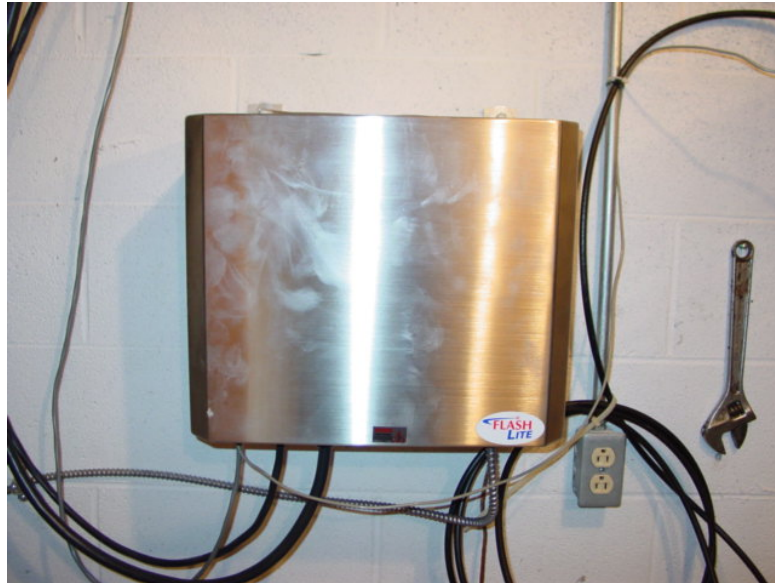
PHOTO SHOWS LIGHTING CONTROL BOX.

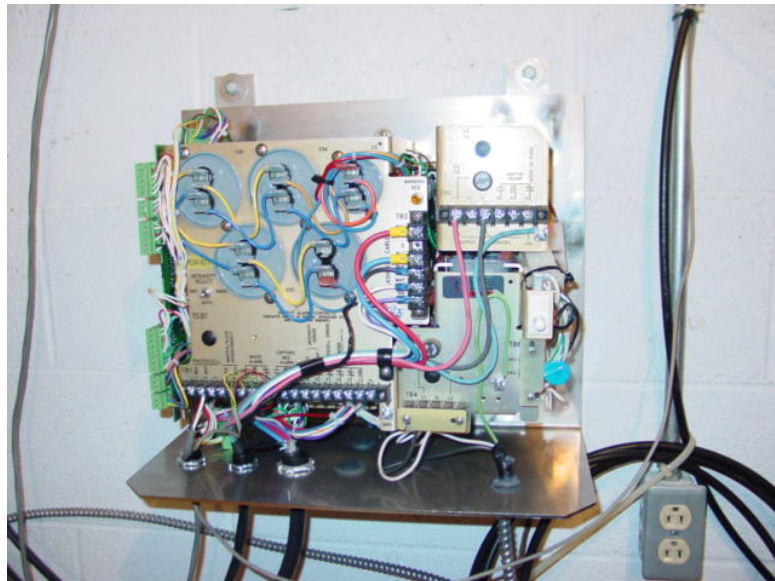
PHOTO SHOWS LIGHTING CONTROL BOX.

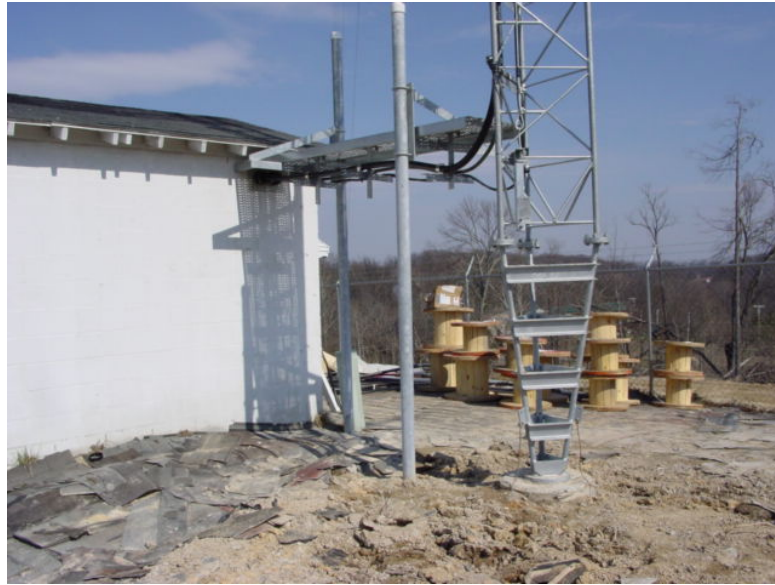
PHOTO SHOWS COMPOUND BUILDING.

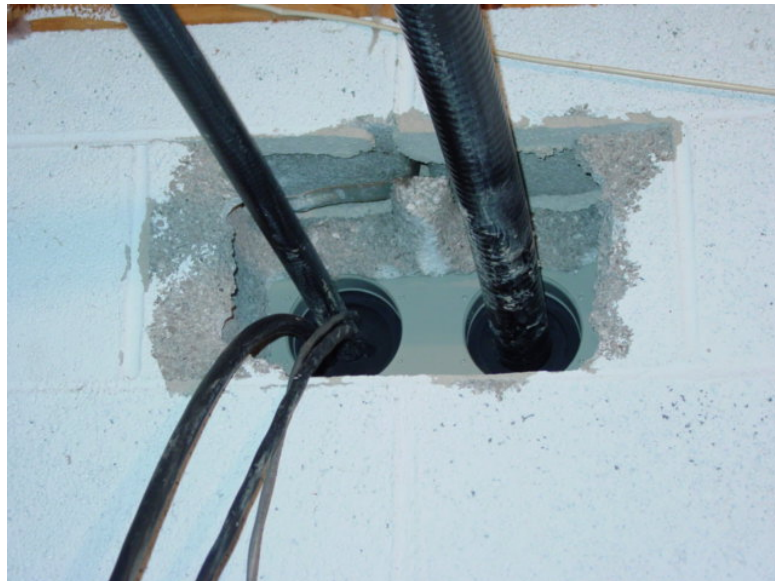
PHOTO SHOWS ENTRY PORT.

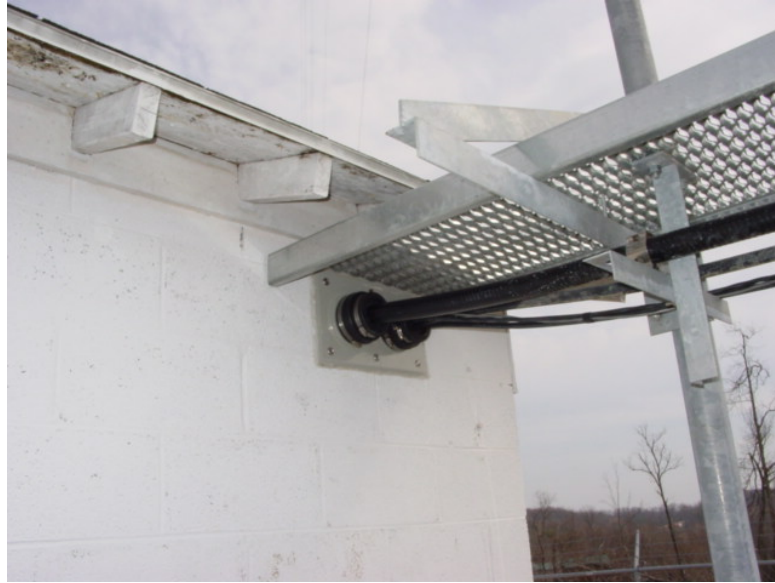
PHOTO SHOWS ENTRY PORT.

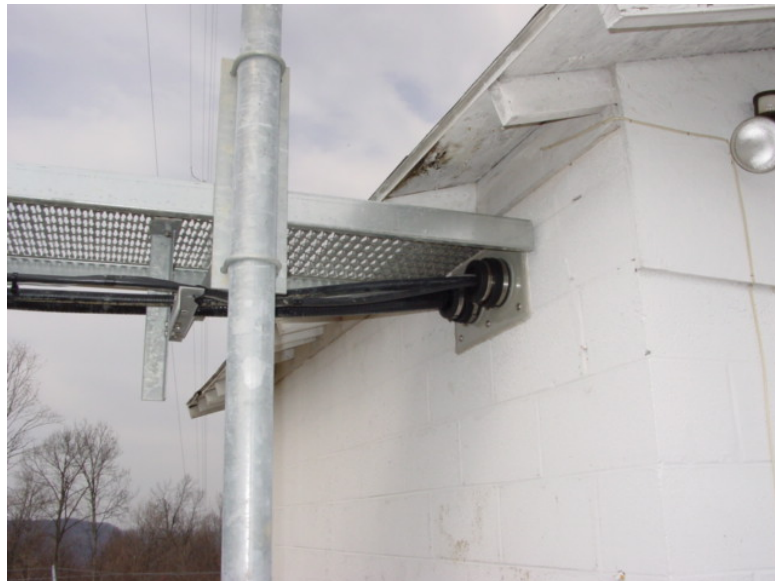
PHOTO SHOWS ENTRY PORT.

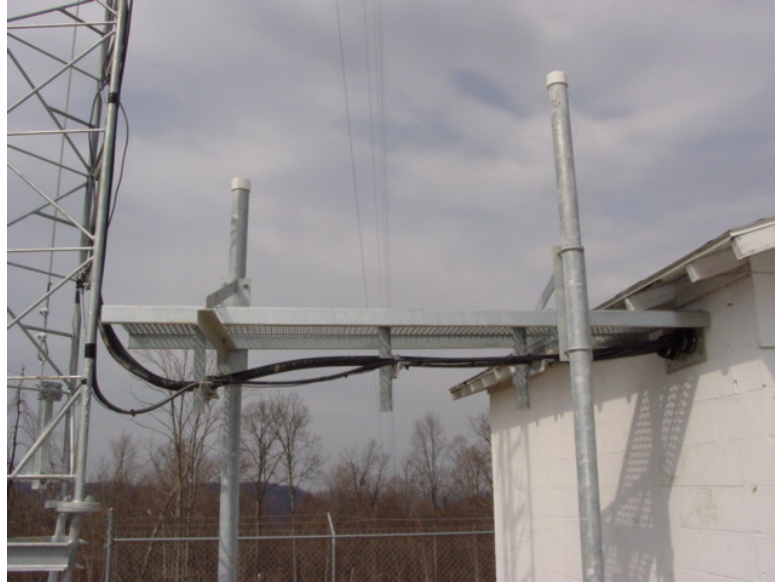
PHOTO SHOWS WAVEGUIDE ICE BRIDGE.

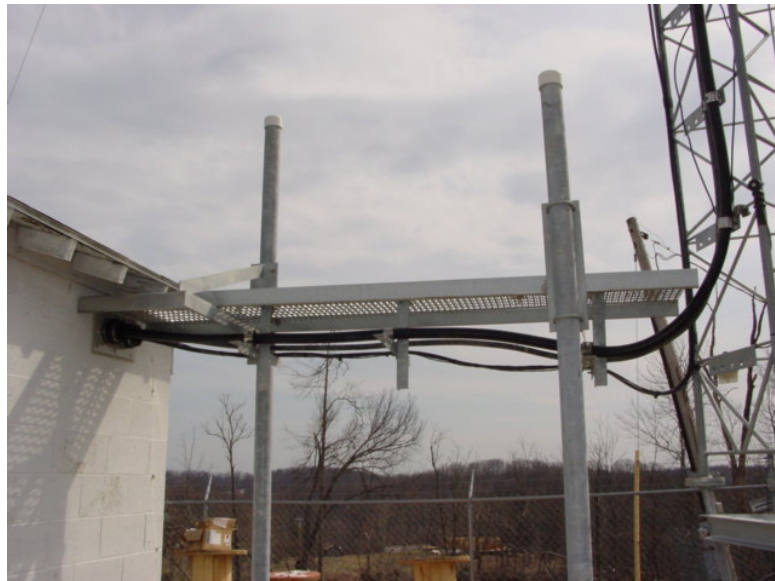
PHOTO SHOWS WAVEGUIDE ICE BRIDGE.

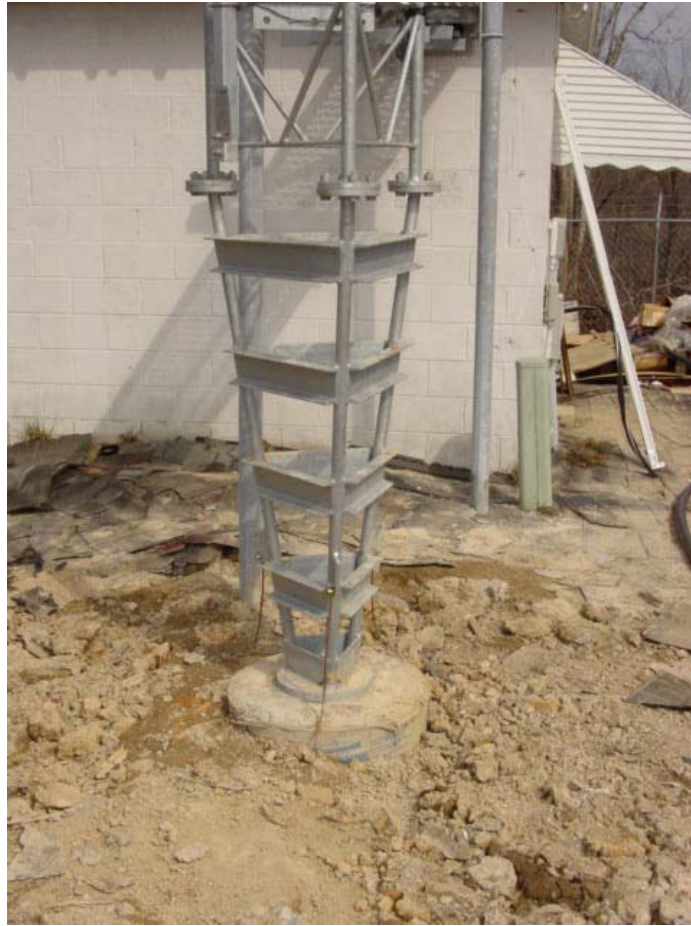
PHOTO SHOWS TOWER BASE AND FOUNDATION.

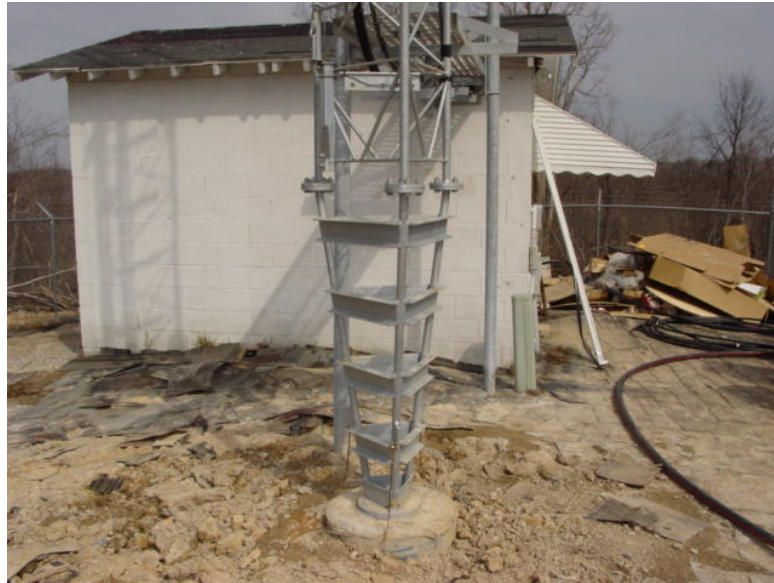
PHOTO SHOWS TOWER BASE.

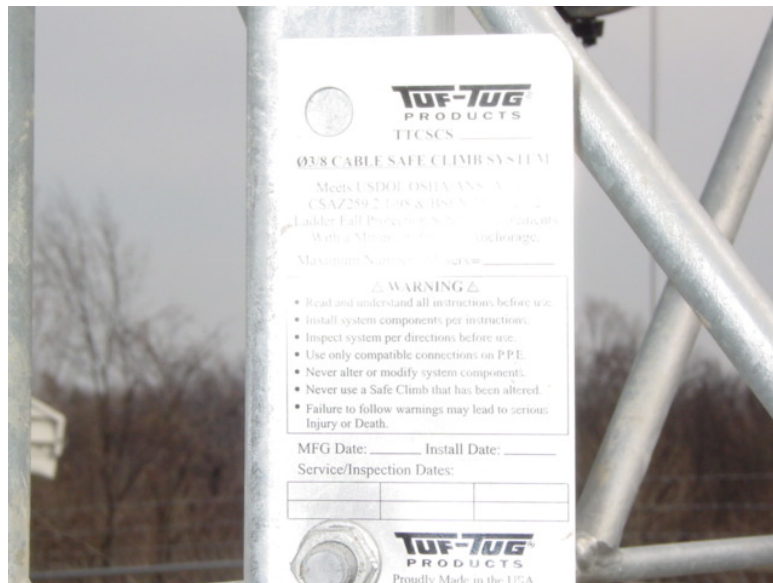
PHOTO SHOWS SAFETY CLIMB ID.

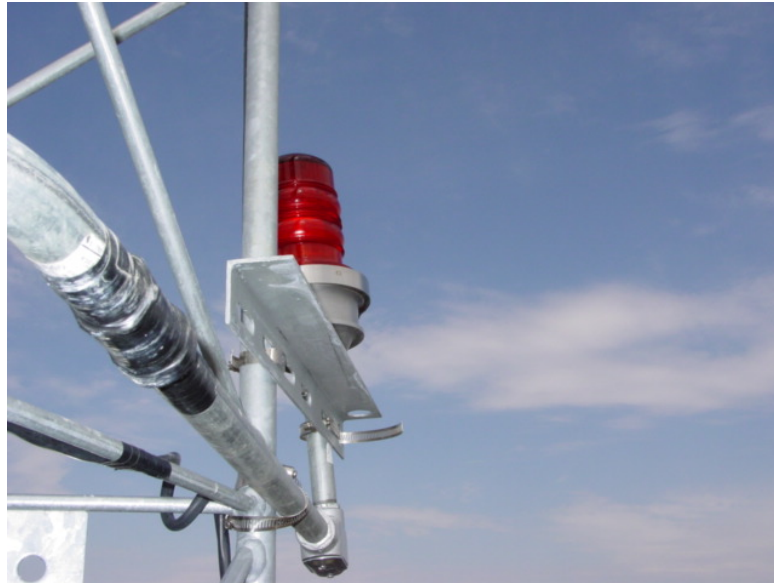
PHOTO SHOWS SIDE LIGHT.

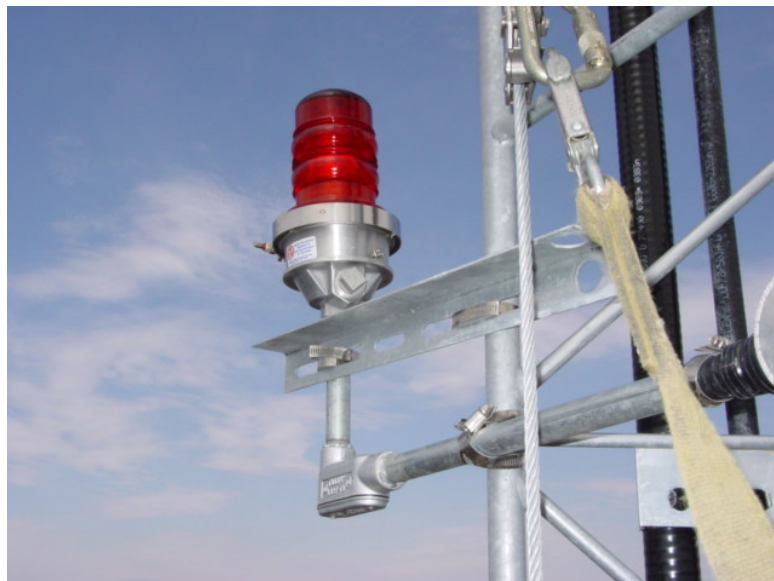
PHOTO SHOWS SIDE LIGHT.

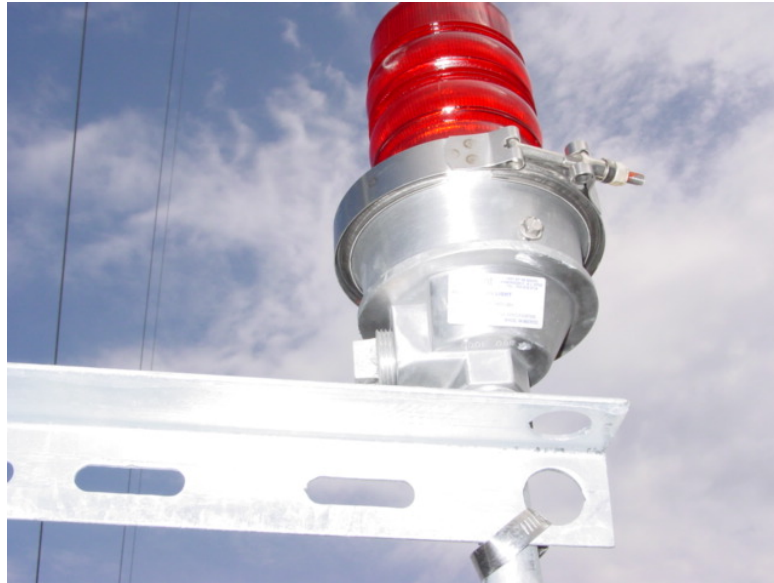
PHOTO SHOWS SIDE LIGHT.

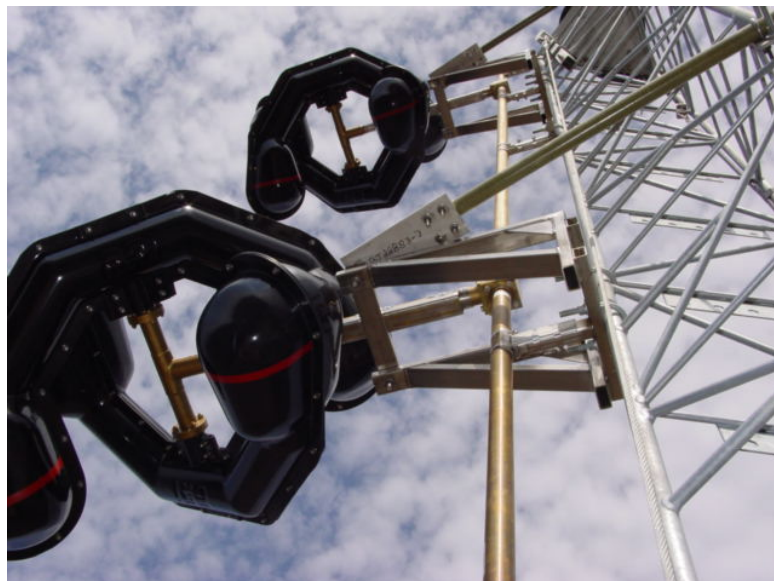
PHOTO SHOWS ANTENNA.

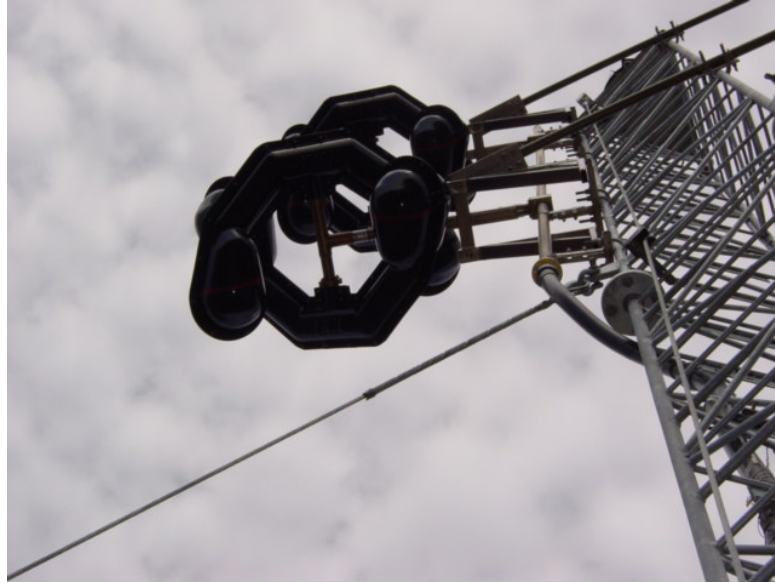
PHOTO SHOWS ANTENNA.

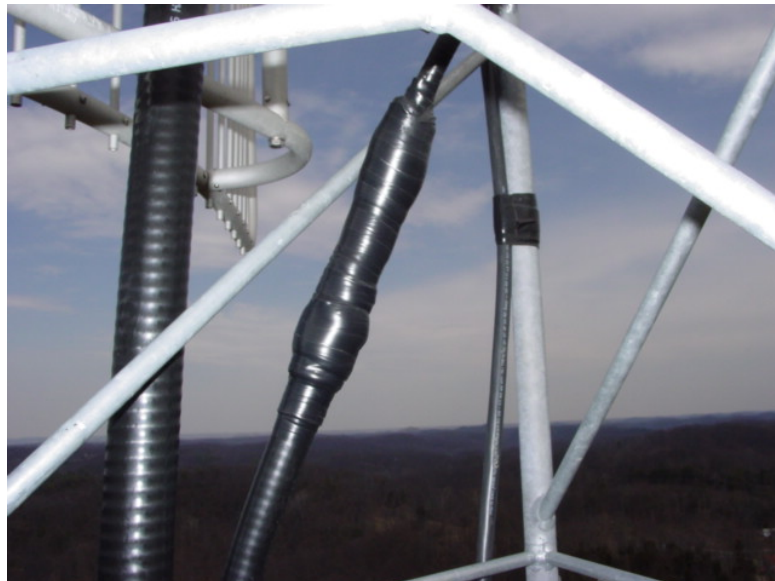
PHOTO SHOWS ANTENNA.

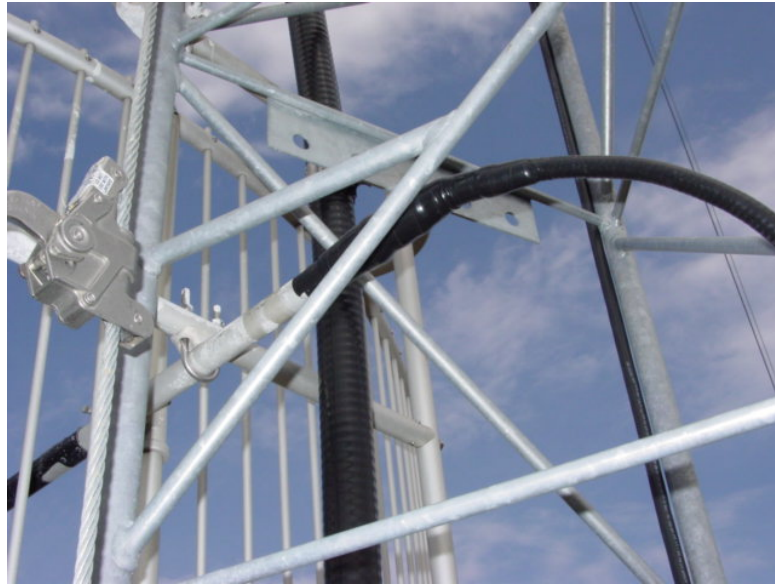
PHOTO SHOWS ANTENNA.

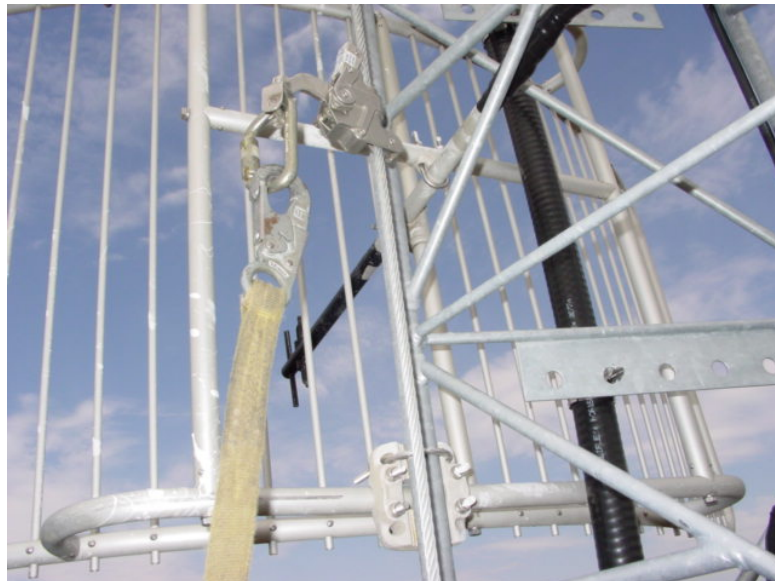
PHOTO SHOWS ANTENNA.

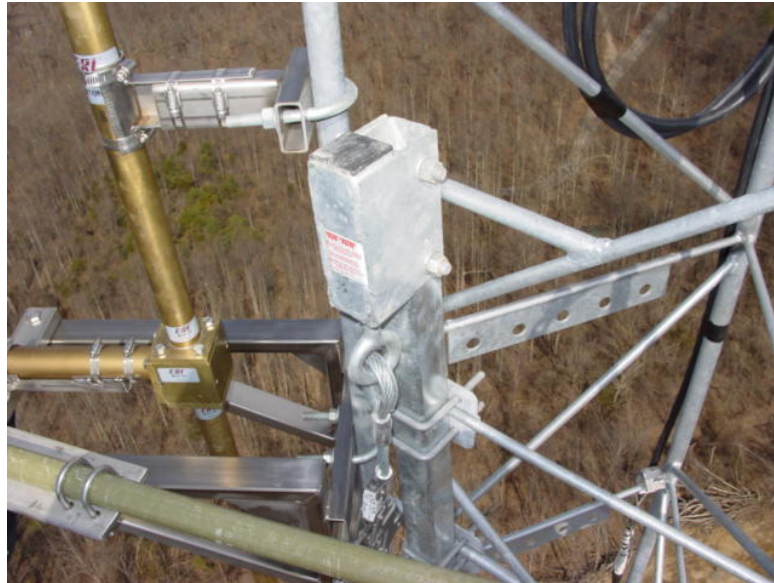
PHOTO SHOWS SAFETY CLIMB AT TOP OF TOWER.

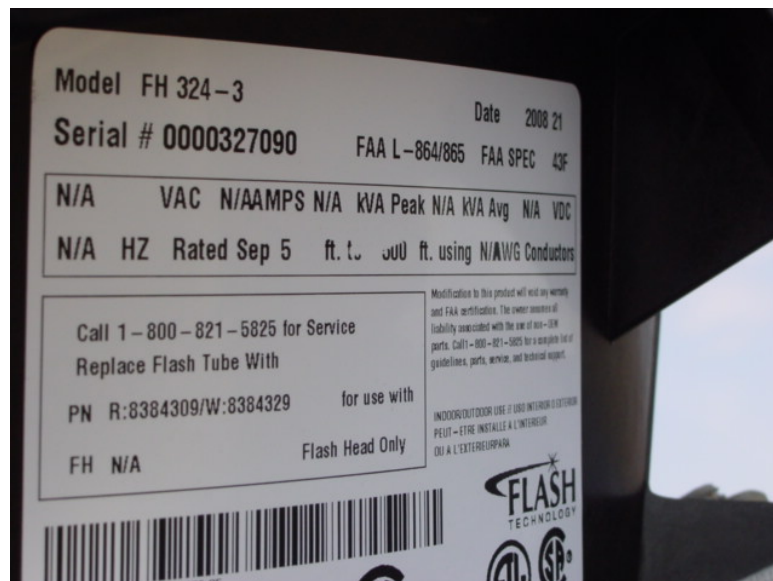
PHOTO SHOWS STROBE LABEL.

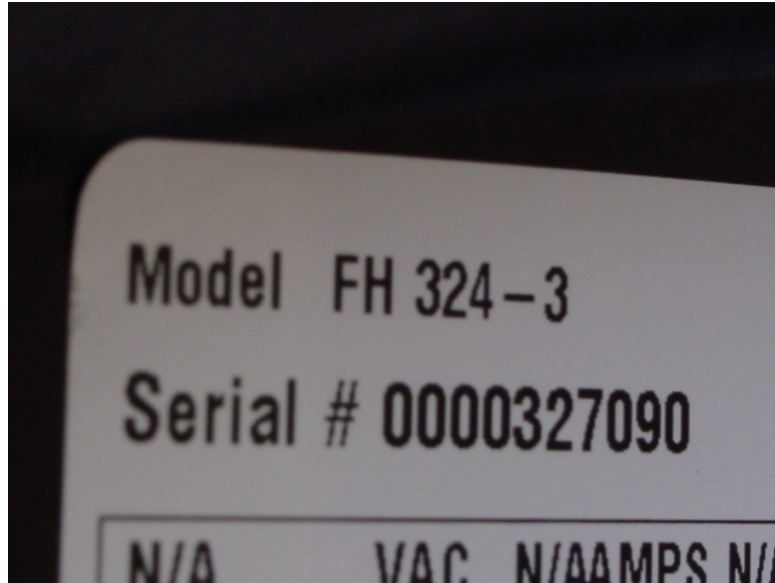
PHOTO SHOWS STROBE MODEL AND SERIAL NUMBERS.

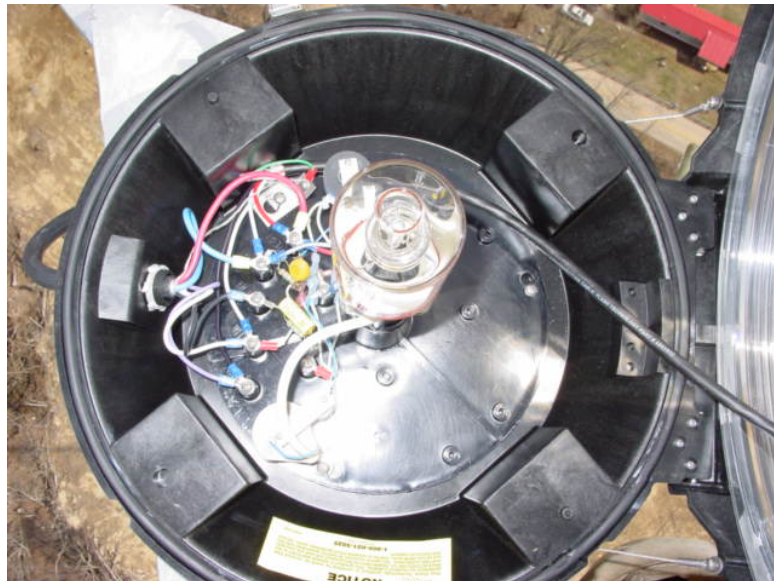
PHOTO SHOWS STROBE.

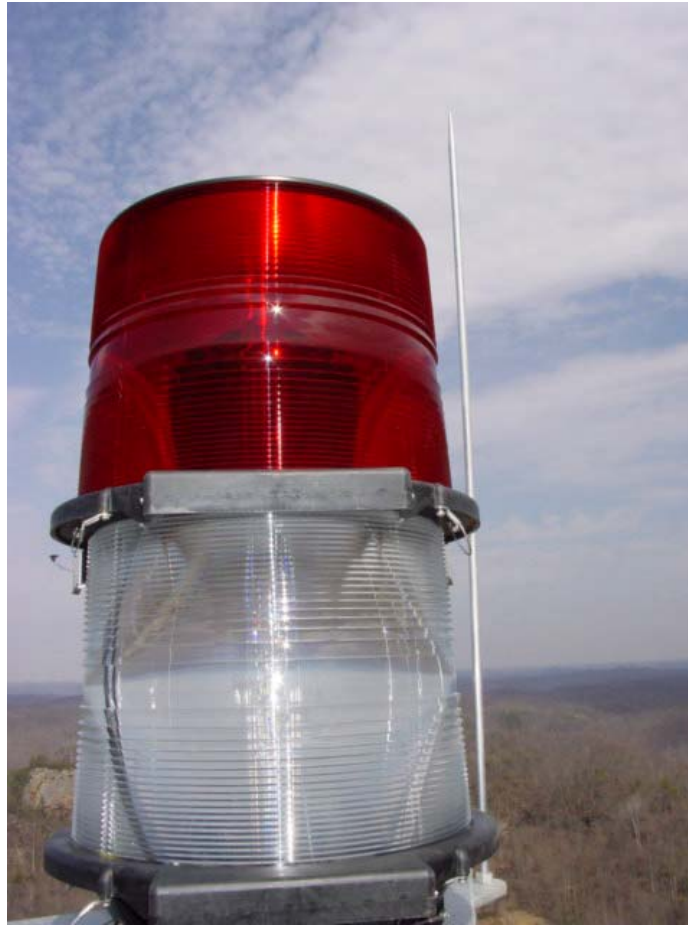
PHOTO SHOWS STROBE AND LIGHTNING ROD.

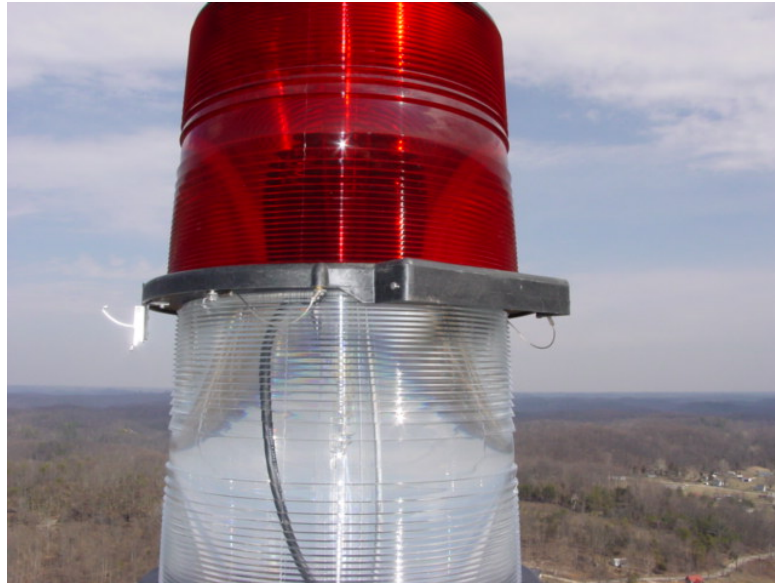
PHOTO SHOWS STROBE.

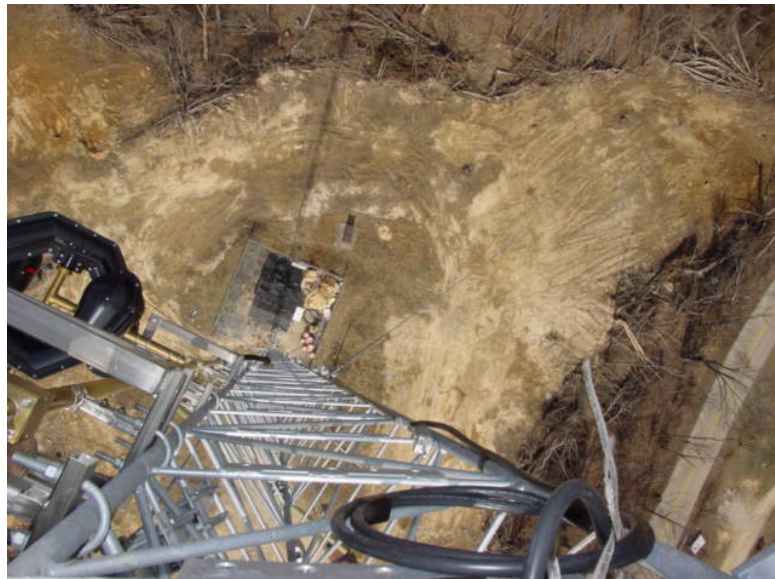
PHOTO SHOWS VIEW DOWN THE TOWER.

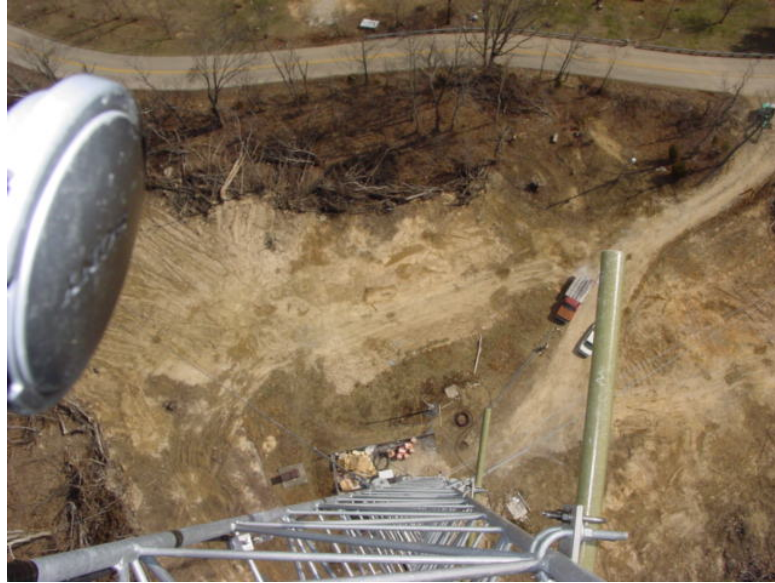
PHOTO SHOWS VIEW DOWN THE TOWER.

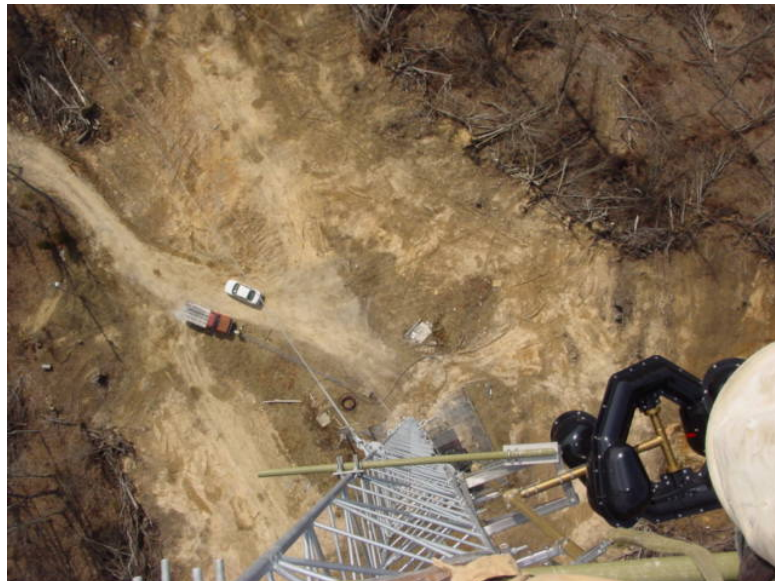
PHOTO SHOWS VIEW DOWN THE TOWER.
